JOINT INVESTIGATION REPORT

INCIDENT NO: 831678 JIV report S/N: 1045

1. Spill incident Number: 831678 2. Type of incident* OIL SPILL
3. Name of Location 24" BOMU - BONNY TRANS NIGER PIPELINE
4. Name of nearest community BODO WEST 5. State: RIVERS 6. LGA GOKANA
7. Type of Production facility/Installation OIL PIPELINE
8. Asset owner/District THE SHELL PETROLEUM DEVELOPMENT COMPANY OF NIGERIA LIMITED | PIPELINE

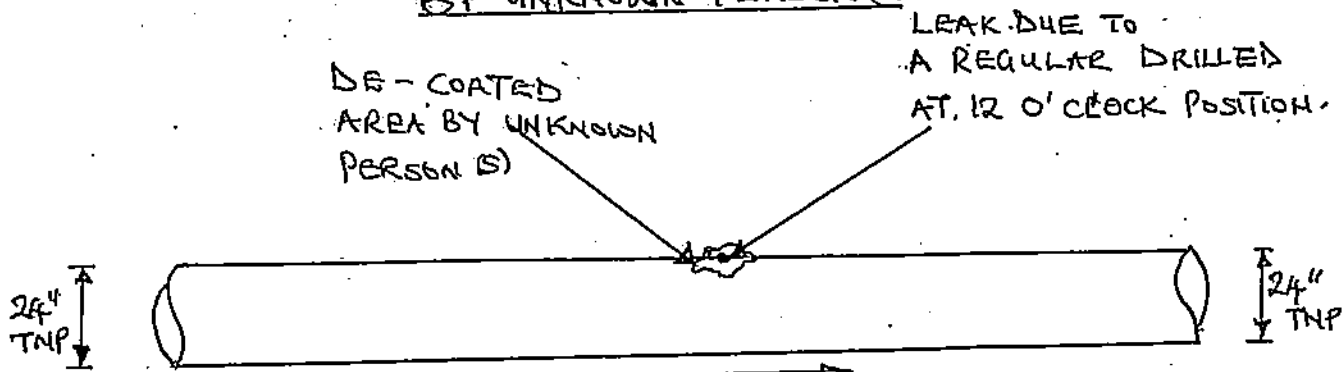
SECTIONAL VIEW OF 24" BOMU - BONNY TRANS NIGER PIPELINE

Additional observations around the spill point: THE JOINT INVESTIGATION TEAM OBSERVED EVIDENCE OF PRIOR REMOVAL OF CONCRETE AND POLYETHYLENE ANTI CORROSION COATING AT THE LEAK POINT.

CORROSION CONTRARY TO THE EVIDENCE AS OBSERVED BY OTHER JIV MEMBERS TO BE A REGULAR DRILLED HOLE AT 12 O' CLOCK POSITION.

AT BOBO WEST SHOWING: A REGULAR DRILLED HOLE AT 12 O' CLOCK POSITION BY UNKNOWN PERSON(S)

REPAIR WORK BY CLAMPING WAS COMPLETED
