JOINT INVESTIGATION REPORT

INCIDENT NO: 831678 JIV report S/N: 1045

1. Spill incident Number: 831678 2. Type of incident* OIL SPILL
3. Name of Location 24" BOMU - BONNY TRANS NIGER PIPELINE
4. Name of nearest community BODO WEST 5. State: RIVERS 6. LGA GOKANA
7. Type of Production facility/Installation OIL PIPELINE
8. Asset owner/District THE SHELL PETROLEUM DEVELOPMENT COMPANY OF NIGERIA LIMITED | PIPELINE

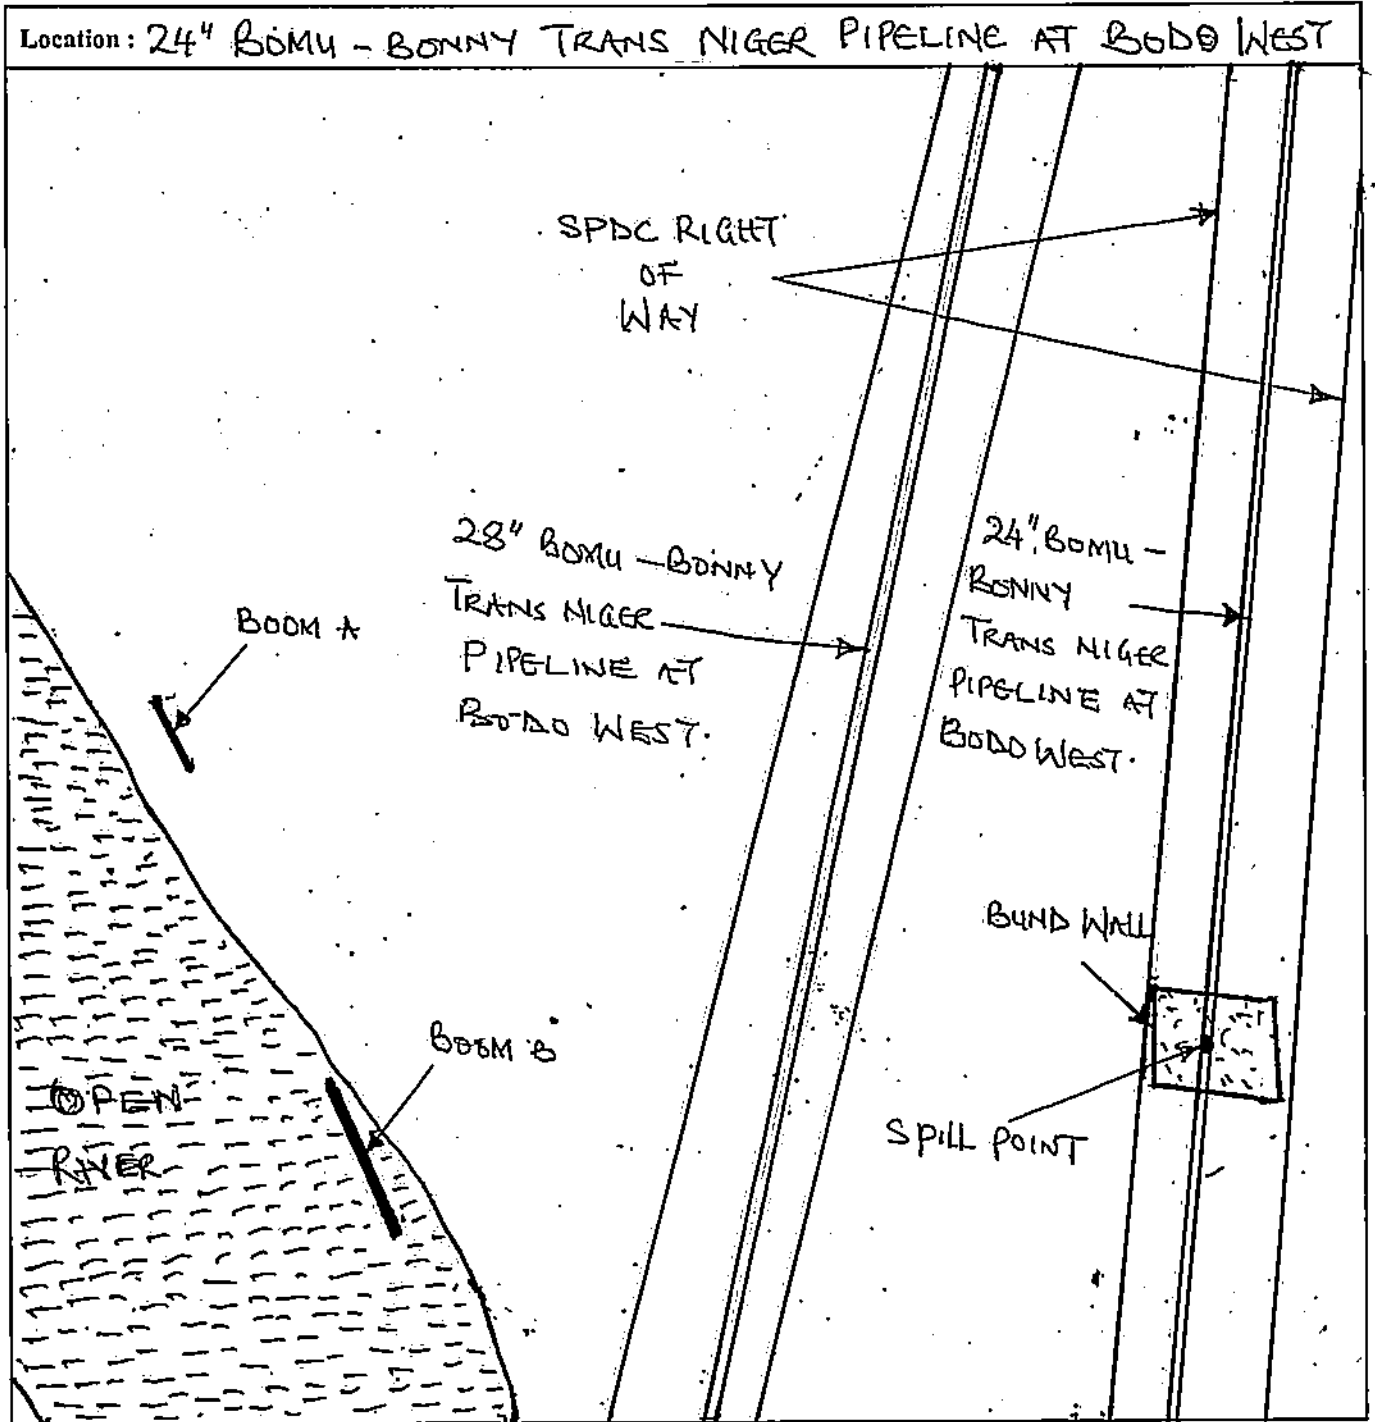
f. Appendix 1: Overview sketch of the site,

Additional observations around the spill point: THE JOINT INVESTIGATION TEAM OBSERVED EVIDENCE OF PRIOR REMOVAL OF CONCRETE AND POLYETHYLENE ANTI CORROSION COATING AT THE LEAK POINT.

CORROSION CONTRARY TO THE EVIDENCE AS OBSERVED BY OTHER JIV MEMBERS TO BE A REGULAR DRILLED HOLE AT 12 O' CLOCK POSITION.

REPAIR WORK BY CLAMPING WAS COMPLETED
